MERIT ESTATES

# Sample - The Address

Level 3 Survey

The Address

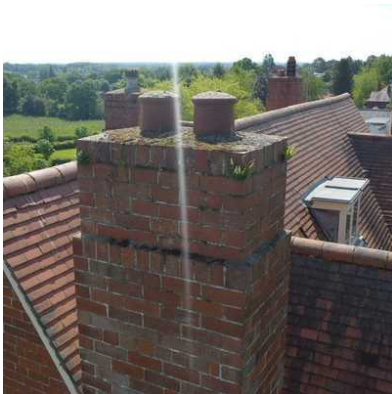
Outside > Chimney Stacks

2. Requires Attention

Foliage growing out of top course of brickwork.  
Repointing repairs advised.

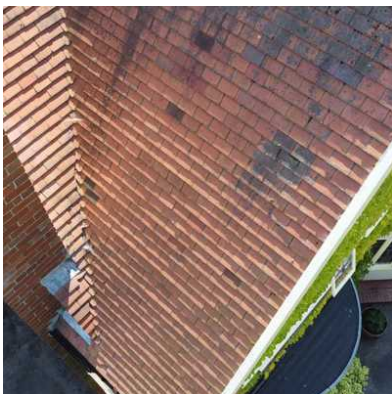
84

1. No Current Issues

No current issues. Historic repairs evident.

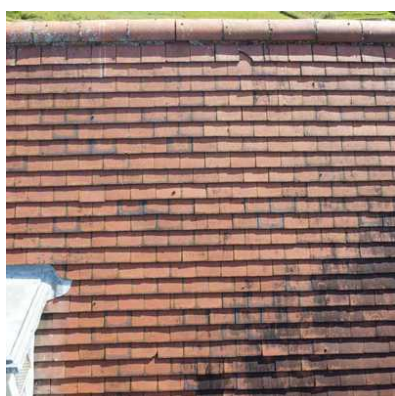
87

2. Requires Attention

Cracked tile below line of ridge requires replacing.

The cement mortar filleting in in the ridge is decaying in areas and requires repointing.

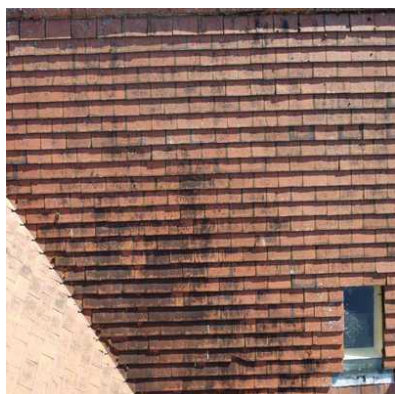
2. Requires Attention

One small cracked tile requires replacement, left of roof light.

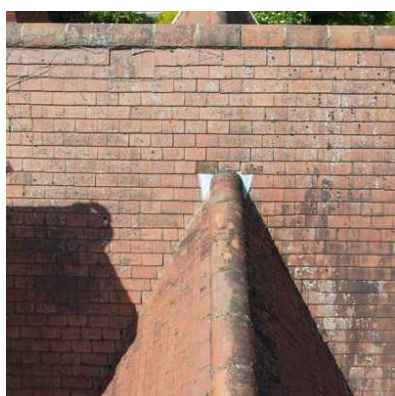
2. Requires Attention

Two missing tiles below ridge. Repairs required.

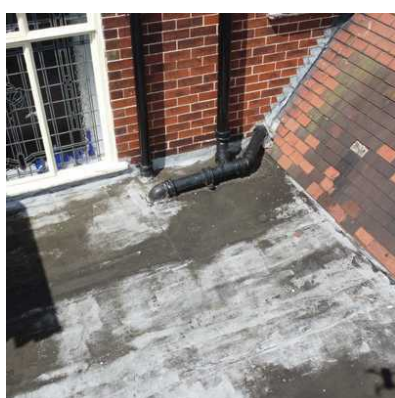
3. Requires Urgent Attention

Missing tile identified on sloped roof covering.

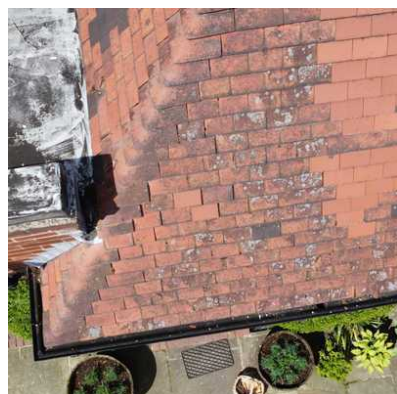
1. No Current Issues

Evidence of numerous replaced tiles.

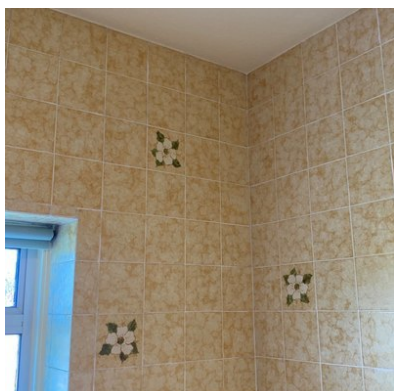
52

There wasn't an extractor fan in place.

3. Requires Urgent Attention

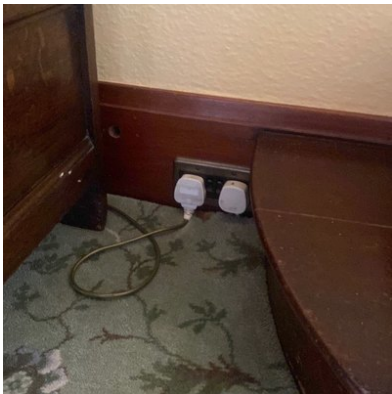
The meter is located in the same place, and whilst it is younger, there was no installation date showing.

3. Requires Urgent Attention

NICEIC guidance suggests that at every change of ownership the electrical installation in the property is tested and as such we recommend this be requested by your Legal Advisor.
