MERIT ESTATES

1 Fictional Way, City, County, United Kingdom, XX1 1XX

About the inspection and report

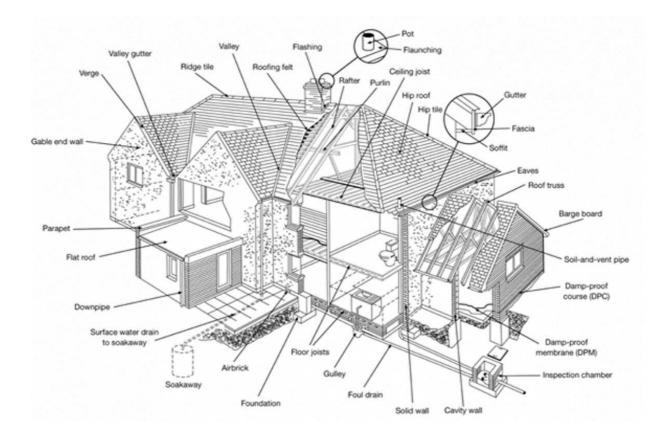
Typical house diagram

This diagram illustrates where you may find some of the building elements referred to in the report.
