MERIT ESTATES

# Sample - The Address

Level 3 Survey

The Address

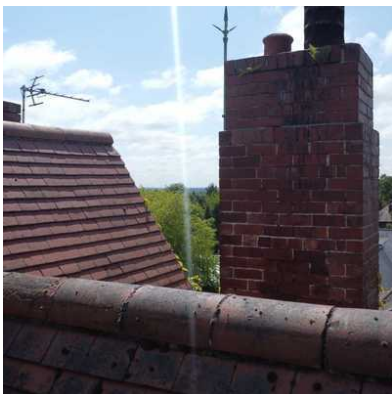
86

Outside > Chimney Stacks

2. Requires Attention

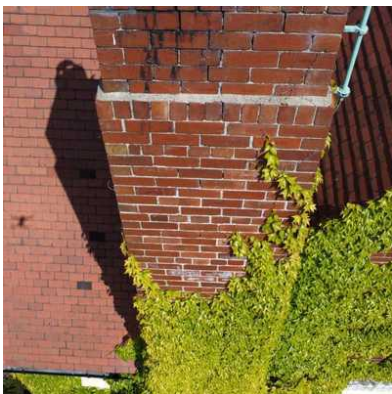
90

Outside > Chimney Stacks

2. Requires Attention

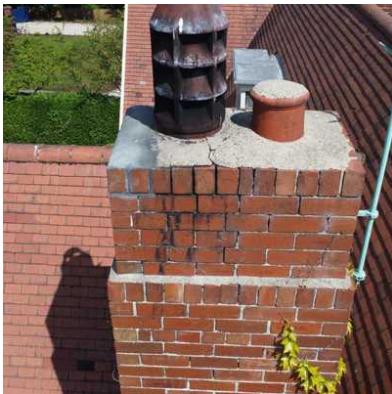
92

Outside > Chimney Stacks

2. Requires Attention

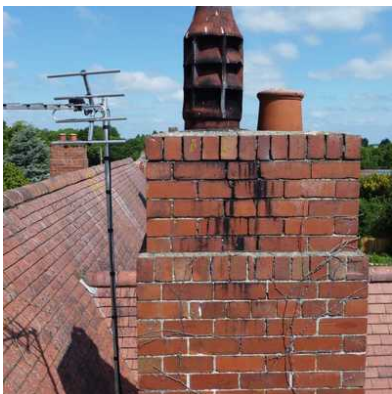
96

Outside > Chimney Stacks

2. Requires Attention

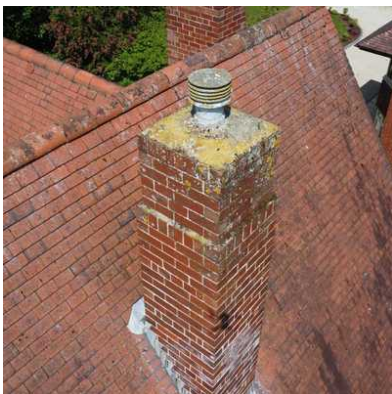
101

Outside > Chimney Stacks

**2. Requires Attention**

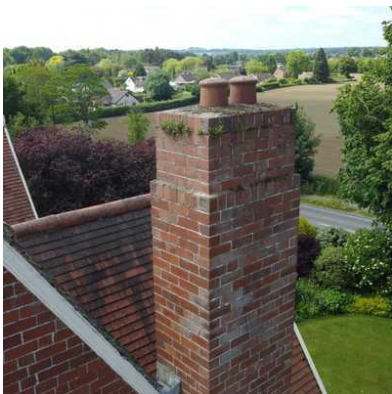
109

Outside > Chimney Stacks

**2. Requires Attention**

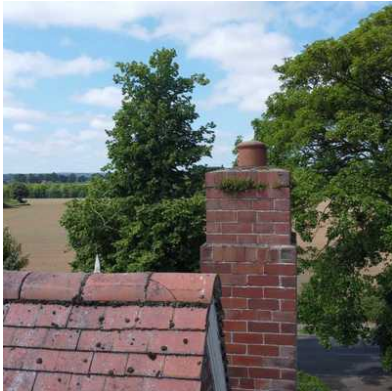
117

Outside > Chimney Stacks

2. Requires Attention

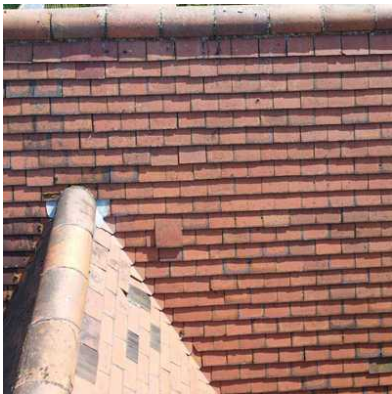
93

Outside > Roof Coverings

2. Requires Attention

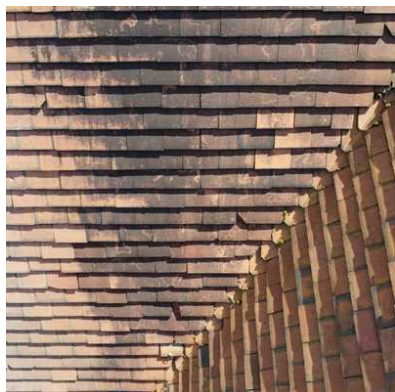
94

Outside > Roof Coverings

2. Requires Attention

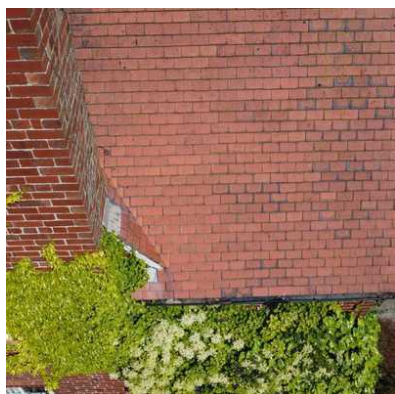
98

Outside > Roof Coverings

2. Requires Attention

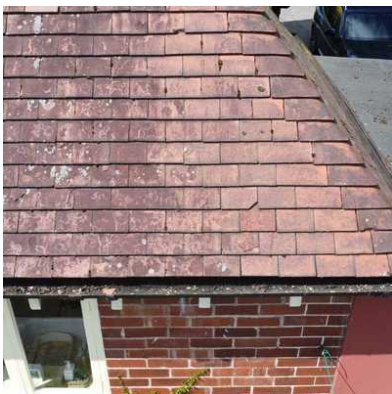
112

Outside > Roof Coverings

2. Requires Attention

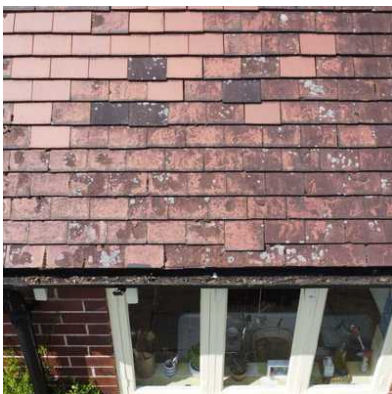
113

Outside > Roof Coverings

2. Requires Attention

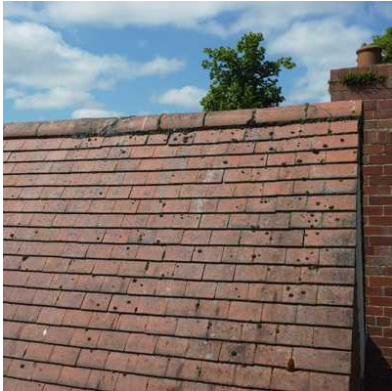
114

Outside > Roof Coverings

2. Requires Attention

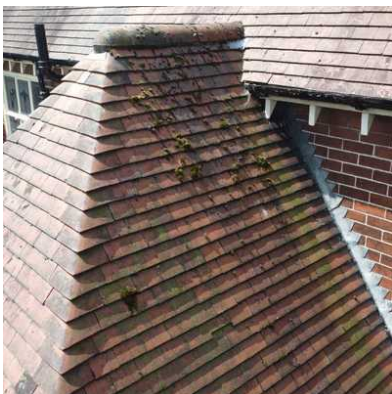
116

Outside > Roof Coverings

2. Requires Attention

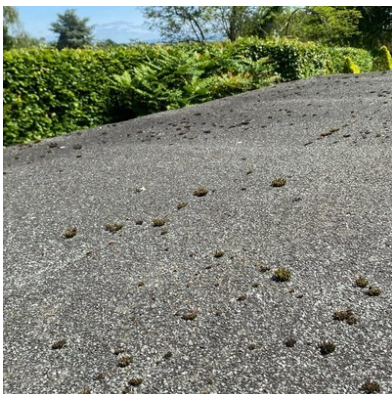
17

Outside > Rainwater pipes and gutters

2. Requires Attention

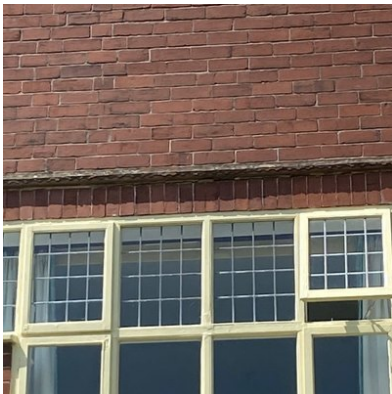
14

2. Requires Attention

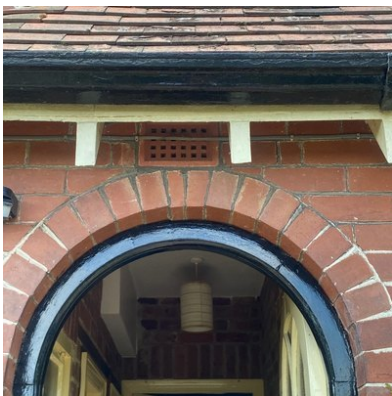
18

1. No Current Issues

Historic lintel repair identified.

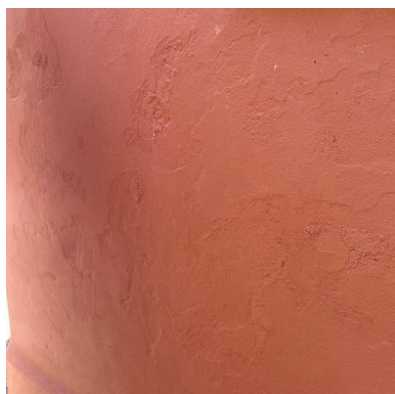
21

2. Requires Attention

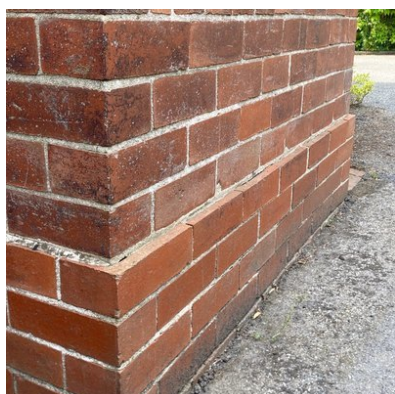
25

2. Requires Attention

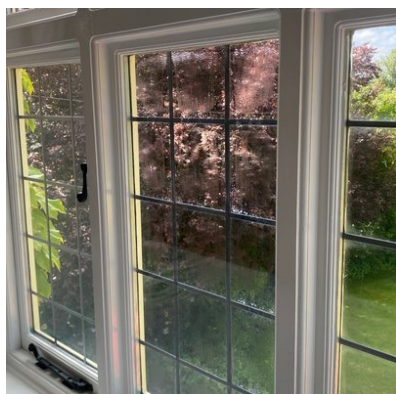
44

2. Requires Attention

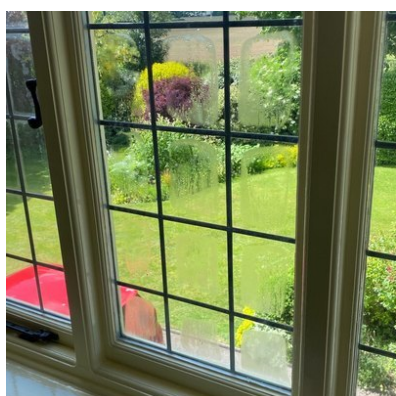
49

2. Requires Attention

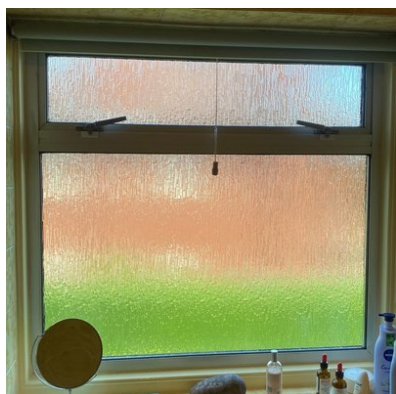
50

2. Requires Attention

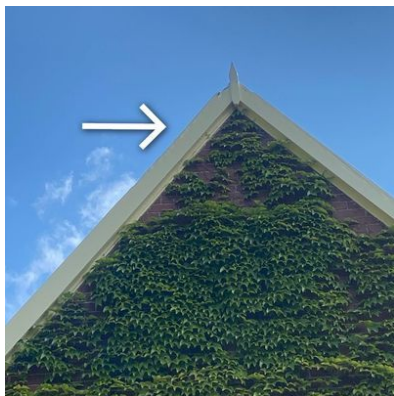
9

1. No Current Issues

Historic repairs on fascia noted.

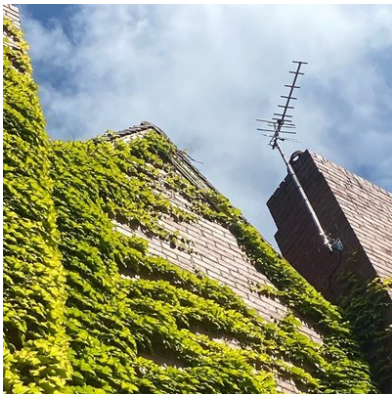
12

This fascia to the south is suffering from rot and decay as result of an attacking creeper plant on this elevation. The moisture within the foliage has impacted the integrity of the timber and as a result, the fascia requires replacing.

**3. Requires Urgent Attention**

Creeper has attacked timber fascia, causing it to rot.

A replacement fascia is required.

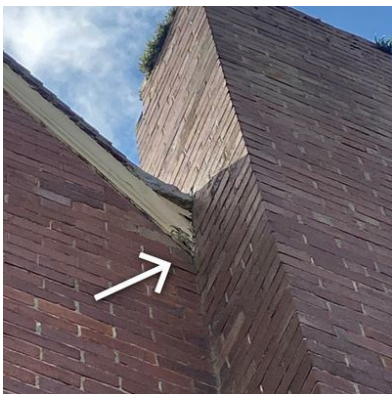
28

The small area of fascia to the north elevation appears to be sucking up moisture from the external chimney stack. As mentioned previously, it is likely the chimney stack is high in moisture content due to the decayed mortar and flaunching.

**3. Requires Urgent Attention**

Rotten fascia board dragging moisture from chimney stack's masonry.

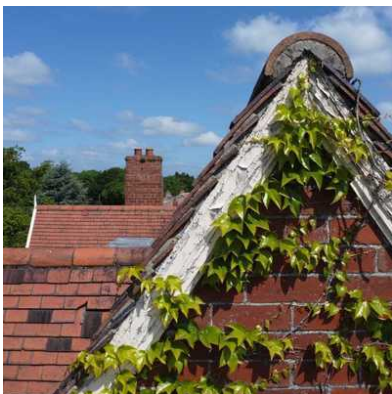
91

**3. Requires Urgent Attention**

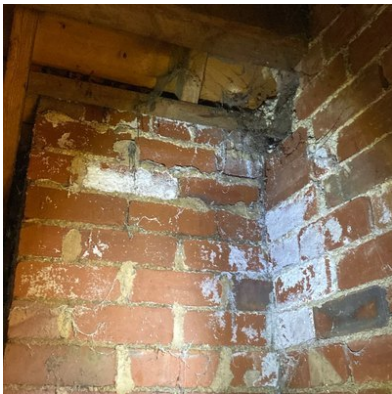
39

2. Requires Attention

High levels of moisture around chimney breast.

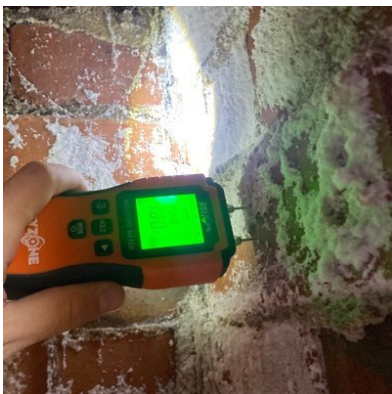
40

2. Requires Attention

Internal efflorescence on central chimney stack, indicating higher levels of moisture.

External repairs required.

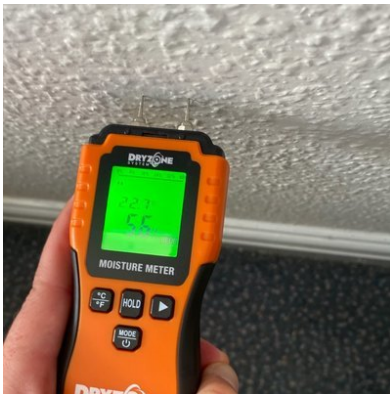
38

Inside > Walls and partitions

2. Requires Attention

Suspected higher levels of moisture on wall near to chimney stack.  
External mortar repairs advised.

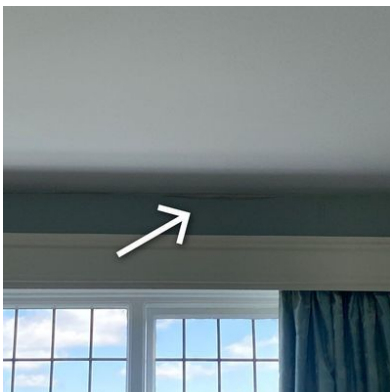
47

Inside > Walls and partitions

2. Requires Attention

Peeling of paper. External lintel repair on mortar joints should prevent water ingress in this location.

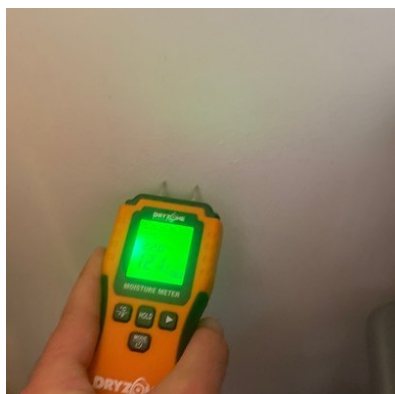
70

Inside > Walls and partitions

2. Requires Attention

12% moisture content on dry lined walls in the flat roof extension.

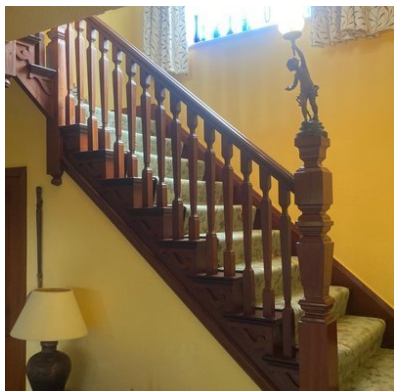
64

Staircase and bannister stable and in sound condition.

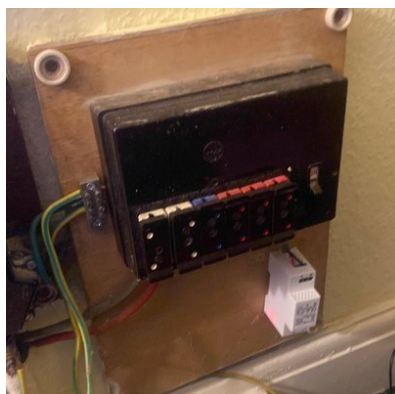
68

Services > Electric

2. Requires Attention

It is advised an in-date and Satisfactory EICR (Electrical Installation Condition Report) is produced prior to exchange.

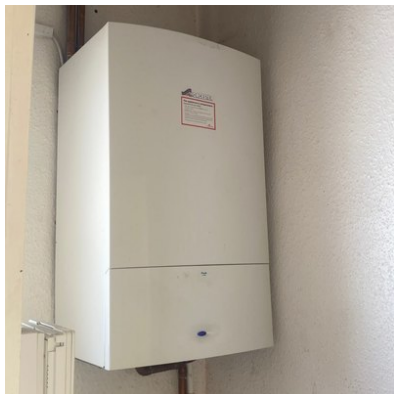
73

The heating systems should be tested annually as part of the boiler tests and should be carried out by a qualified Heating Engineer.

Services > Heating

1. No Current Issues

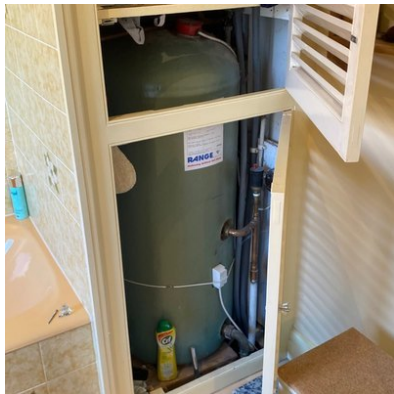
55

The cylinder and immersion were not tested.

The hot water at the tap was tested and seen to be functioning, with exception to the low pressure identified on the bathroom basin.

Services > Water Heating

1. No Current Issues

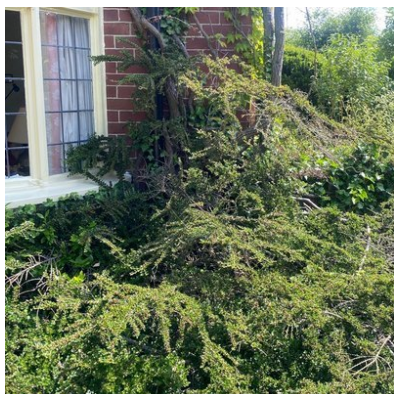
11

Services > Drainage

**NI. Not Inspected**

If the purchaser has concerns over the drainage of the property, either internally or externally, we recommend instructing a Drainage CCTV Surveyor to map the drains. Merit Estates cannot be held liable for any issues that stem from poor drainage or incorrect pipework.

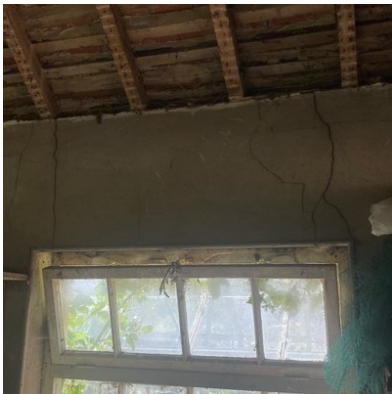
78

Internal cracks above lintels.

There are several distinct cracks on the front elevation pillars and above the lintel of the door. It is advised they are repointed and observed.

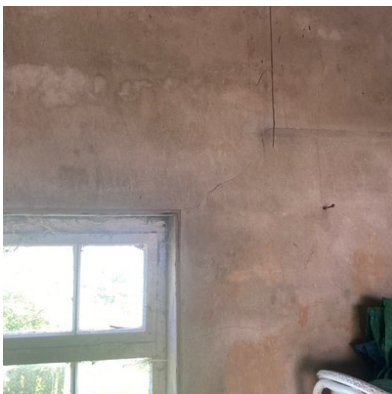
79

Internal cracks above lintels.

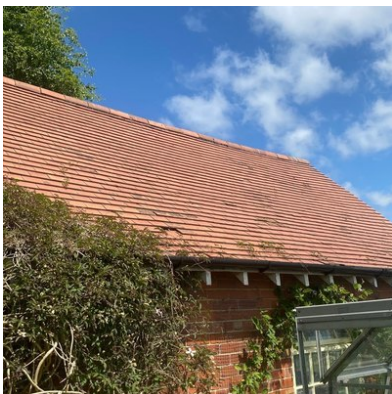
80

The garage roof was in a structurally sound condition, where able to inspect. The sheltered covering requires clearing of debris to protect the tiles. There are a couple of missing tiles on the southern elevation that require replacement.

Missing slates on roof covering.
